## **SCHULTZ FIRE – Waterline Road Hazard Assessment**

14 July 2010

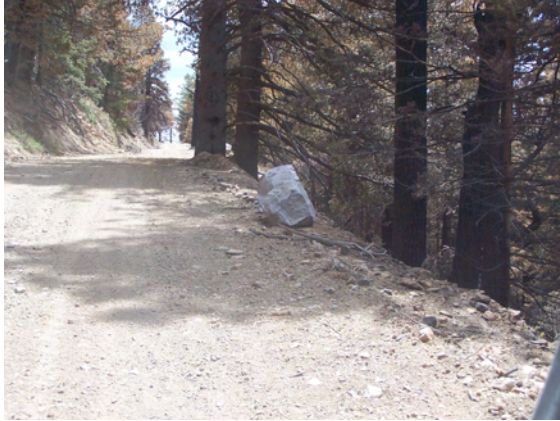
Rocks rolling onto the road are now common. Not all are this large – many are fist sized – but larger ones than this are upslope and unstable. Even the small ones will injure or kill – the larger ones will damage equipment or vehicles. Rock fall can be expected to increase in the coming months, and will not stabilize for upwards of three years. ***Vehicles should not stop or park below rock outcroppings; Driving should be done in teams of two, so that one may continually look upslope to watch for rolling/falling rocks.***

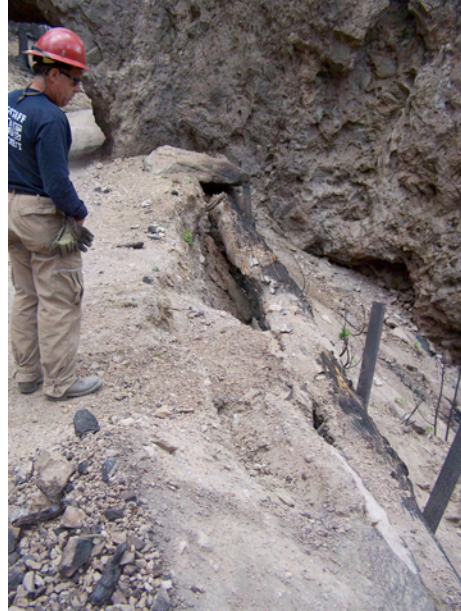
In places, the roadbed was built with log supports. These have burned, and erosion is already evident. ***Immediate replacement and stabilization is warranted.***

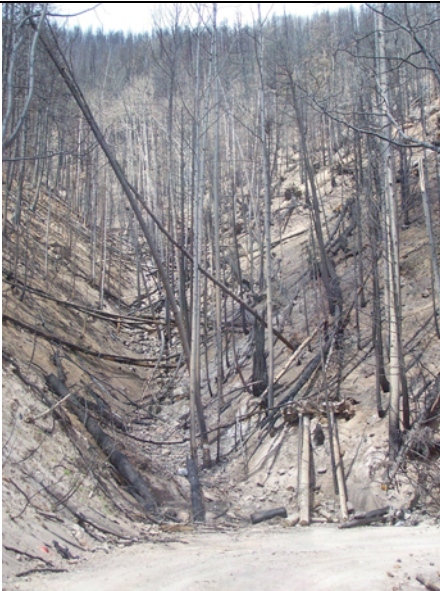
Numerous very steep and totally burned-out drainages cross the road, ***each a high volume, life-threatening avenue for debris and muck*** resulting from a heavy downpour settling over the area. Not all are being “armored” (rocked) during the Rehab work currently underway. The total lack of vegetative matter will accelerate the highly erosive nature of the soils, resulting in catastrophic flows.

Not all drainages are as steep as those depicted on the left, but all have significant severely burned areas uphill. ***Vehicles should not stop where the road crosses a drainage, and those working/traveling on the road need to be especially alert to any thunderstorm activity in the area. Should storms threaten or flows develop, individuals must immediately move to those locations where the road crosses a ridgeline and wait-out the event.***

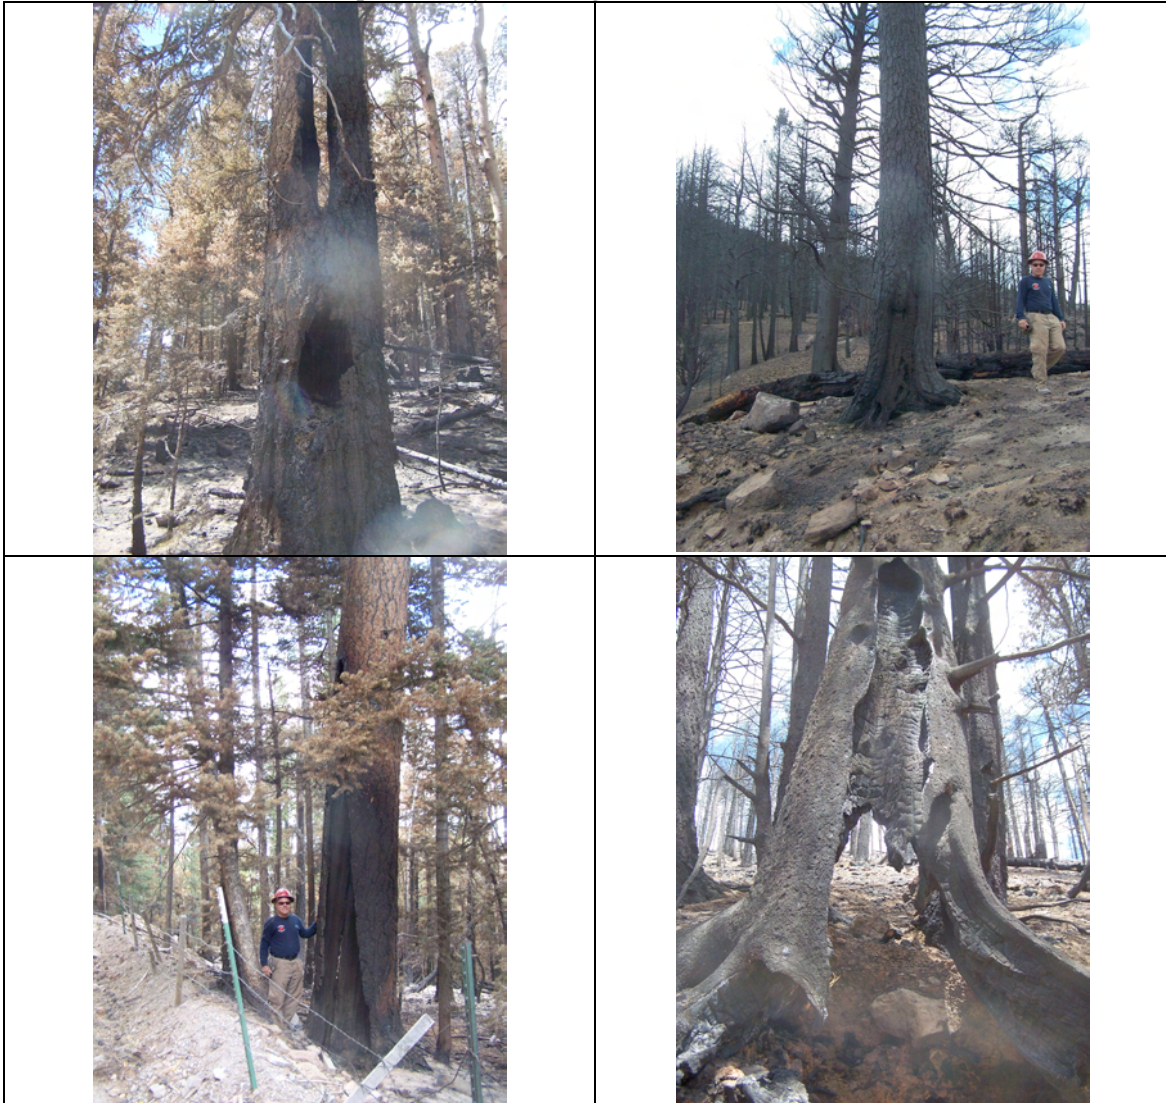
But by far, the most prevalent hazard along the road are the burned-out, root-damaged trees. Consisting of aspen, fir, and pine, many are of significant size.

We estimate from 1,500 to 3,000 of these hazard trees exist within one-tree length of the nine miles ( $\pm$ ) of severely burned area the road traverses: all demand attention. (Note: This total is not all the fire damaged trees along the road within one tree-length - only the number that require removal.) Because of the size, condition, and location, skilled fire personnel are the only ones who should even be considered to do this work.

Duration: Two months (45 work days): 4 Saw Teams @ 15 trees/day each

Crew: FFD Saw Detail ("C" Certified fallers + Swampers)

Cost Estimate: \$155,000

Begin: As soon as possible
